Structural Concrete Laboratory

Kobe University, Graduate School of Engineering, Department of Civil Engineering

Crack propagation in concrete damaged by ASR using image analysis

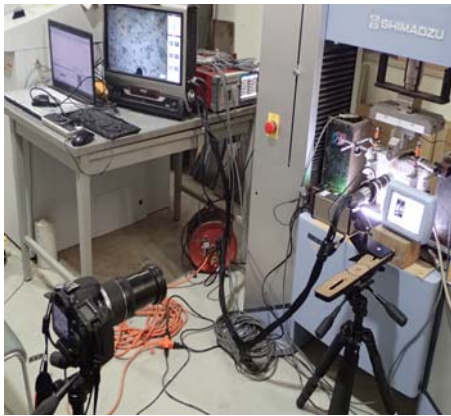
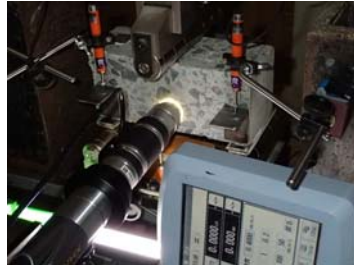
The alkali-silica reaction (ASR) is a reaction which occurs over time in concrete between the alkali in cement matrix or permeating from outside and the silica causing cracking in concrete. Image analysis technique is very suitable to understand the tensile strain developed at crack tip due to ASR.

Loading test setup
Observations are made using high-quality digital camera and microscope.

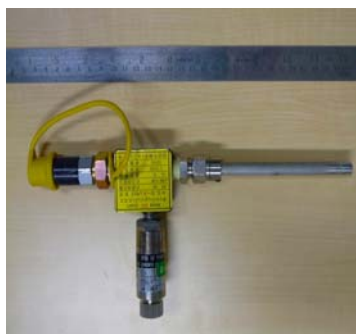
Developed jack

It is required to introduce more of prestressing force to degraded PC structures to satisfy the designed prestress level. However, if not properly grasped the remaining prestressing force, and excessive pre-stress is introduced, the result may be the buckling of the structure. Thus, to accurately estimate the pre-stressing force, we propose an estimation method using the newly developed force applicator device (we call Expansive Jack) and the circular hole near the stress concentration.

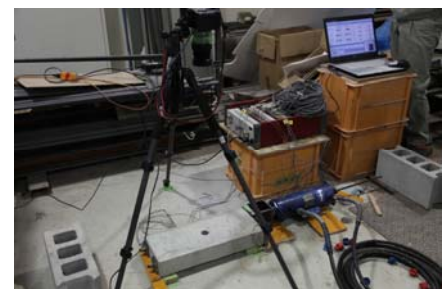
We can measure the strain in a specific point in the strain gauges, in addition to measuring the planar strain distribution around a circular hole by using image analysis.

Concrete strain measurement by using image analysis
